**MILLPORT TOWN HALL  
REPAIRS AND CONVERSION TO  
COMMUNITY FACILITY**

**FEASIBILITY COSTS  
FOR**

**FRIENDS OF MILLPORT TOWN HALL**

**MAY 2019**

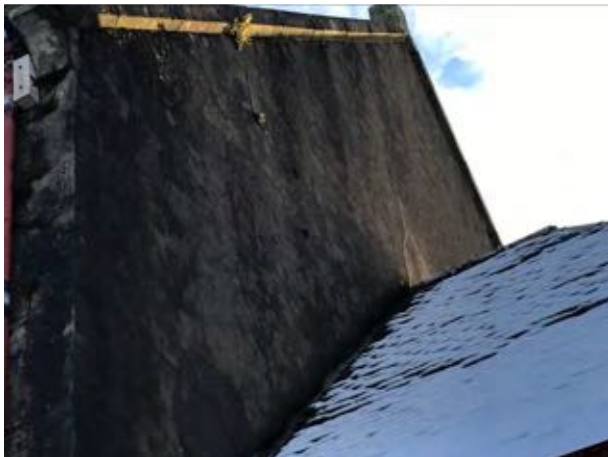
Photo 3. Cracking to high level render

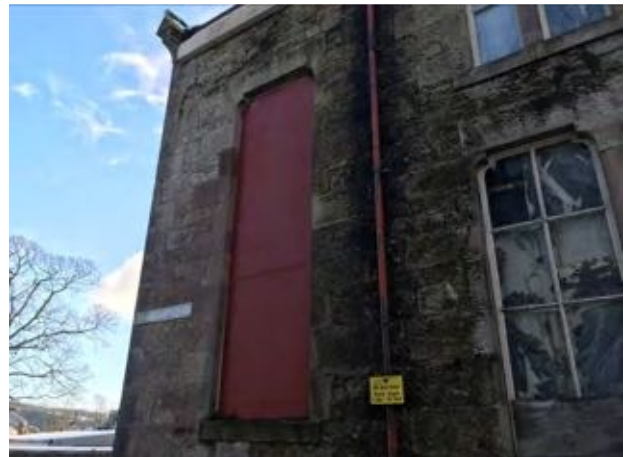
Photo 4. Water staining around downpipe

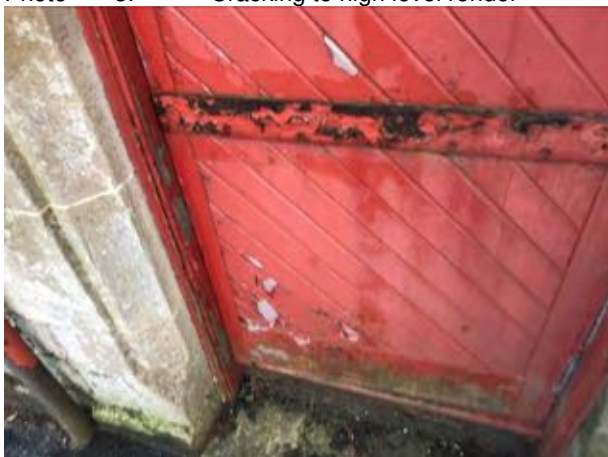
Photo 5. Decaying escape door

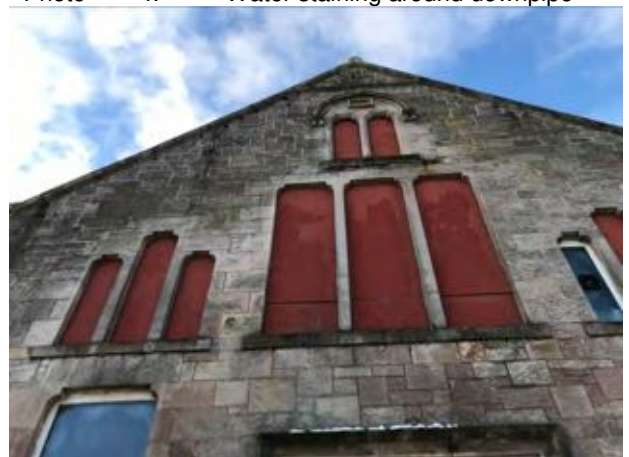
Photo 6. Previous mortar repairs to front elevation

- mortar pointing repairs poor and appears to be cementitious in nature. Areas of vegetation growth.	Rake out and repoint areas of poor pointing	U	3,600

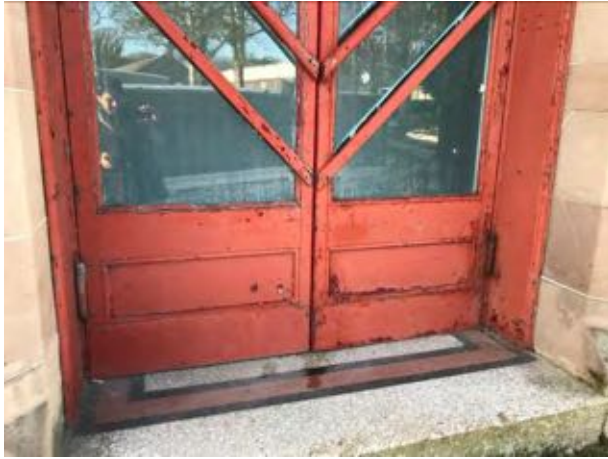
Photo 7. Timber decay to front doors

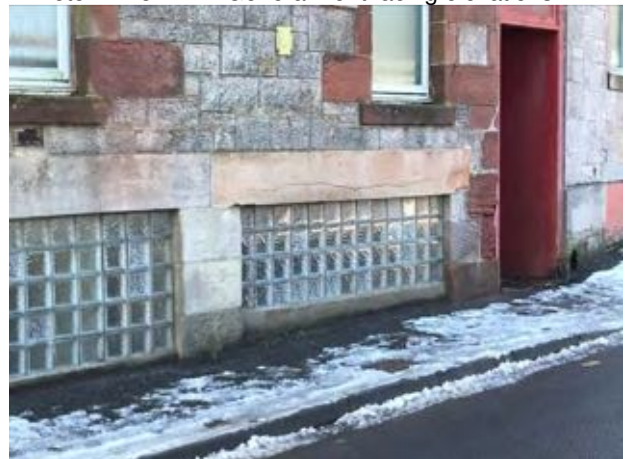
Photo 10. Cracking across lintel to basement windows

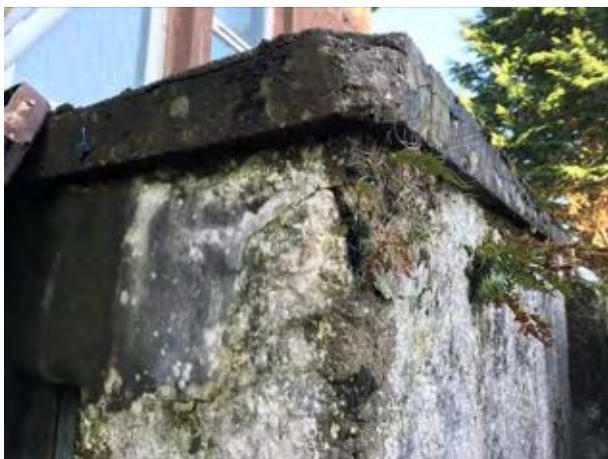
Photo 11. Cracking and vegetation growth to basement toilet entrance

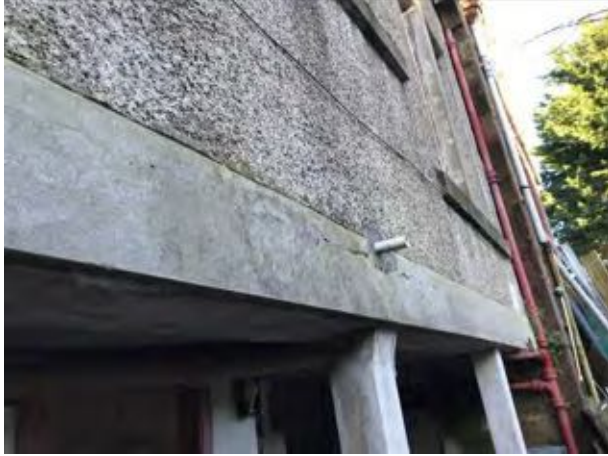
Photo 13. General cracking to structure of south-east extensions

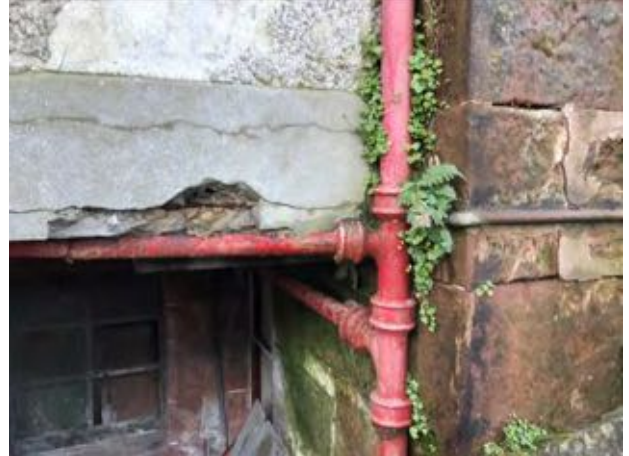
Photo 14. Corrosion to embedded steelwork

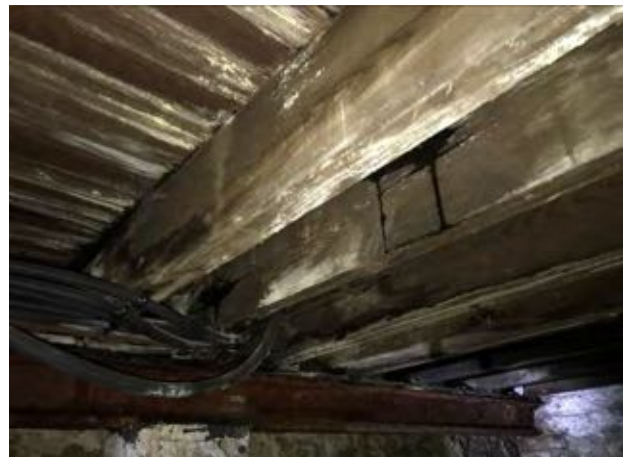
Photo 16. High moisture levels and staining to timbers in basement

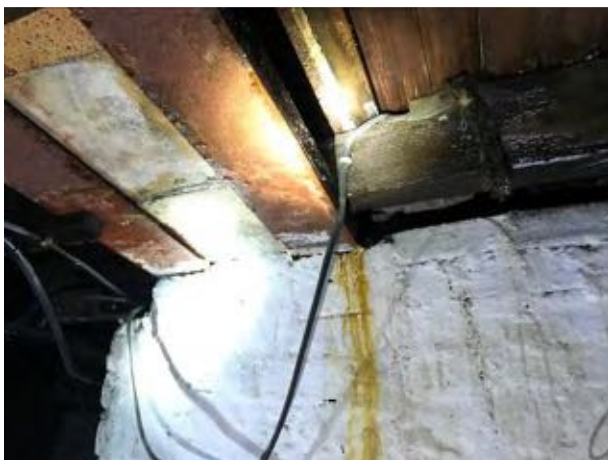
Photo 17. Corrosion to steelwork in basement

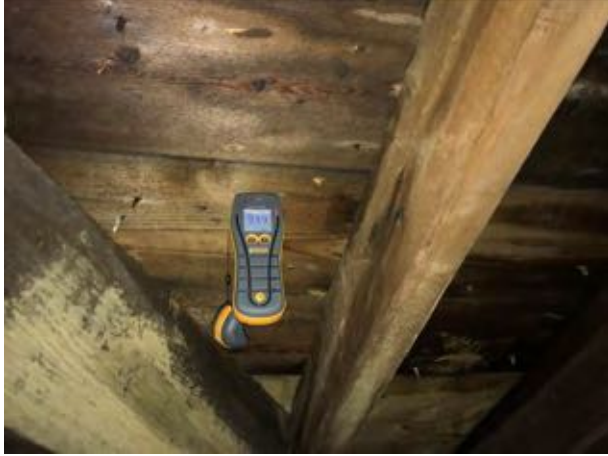
Photo 19. High moisture readings to timber sarking and corroding nail fixings

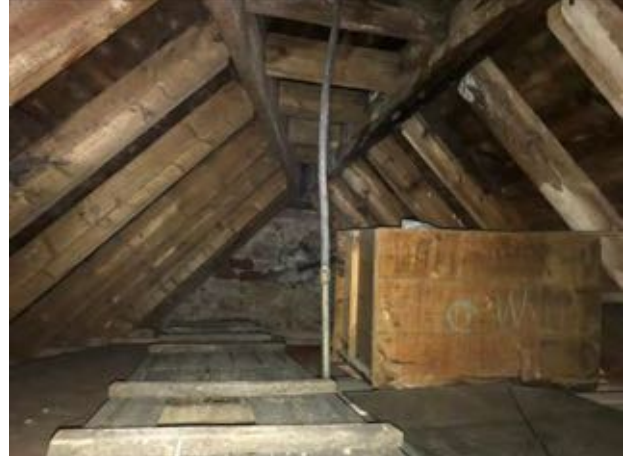
Photo 20. View of water staining and previous timber repairs to roof void

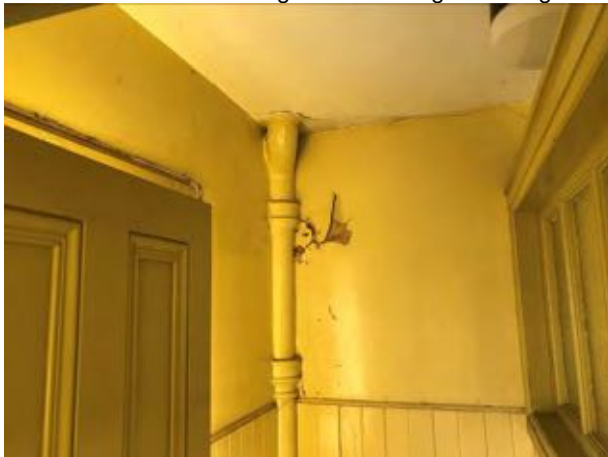
Photo 21. Water damage around downpipe

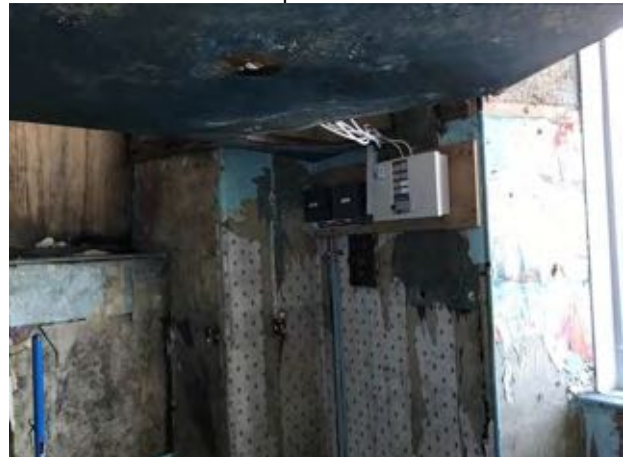
Photo 22. Mould growth and high moisture levels in store at main entrance

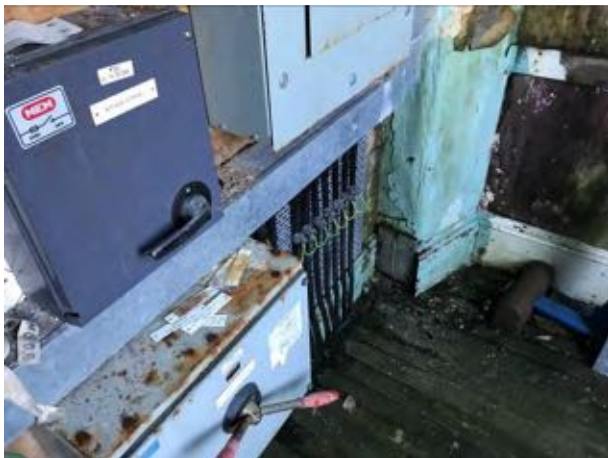
Photo 23. Corroding electrical switchgear

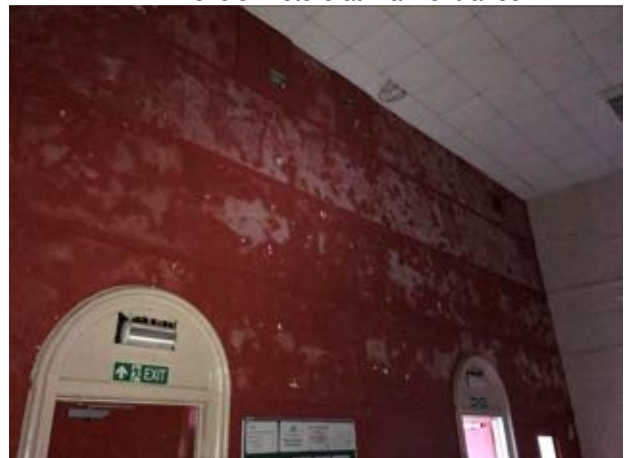
Photo 24. High moisture levels and mould to wall within main hall

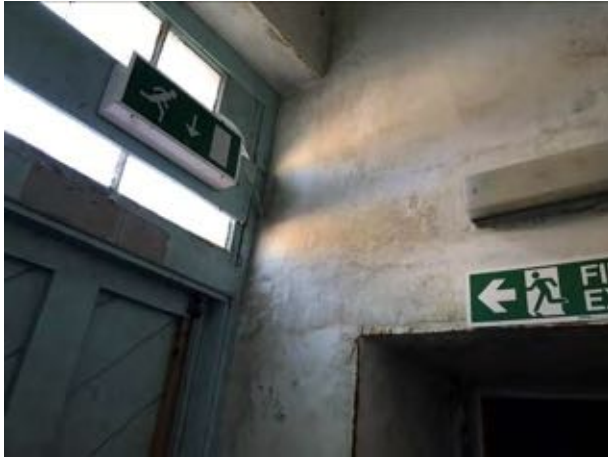
Photo 25. High moisture readings and cracking around door lintels at north-west corner of building

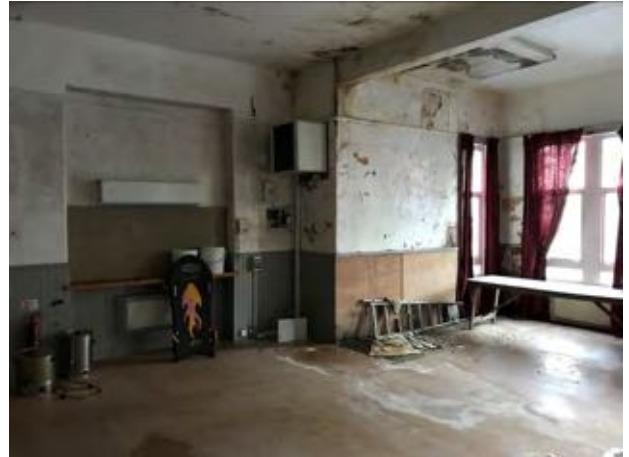
Photo 26. Severe water ingress/damage within room 0/012

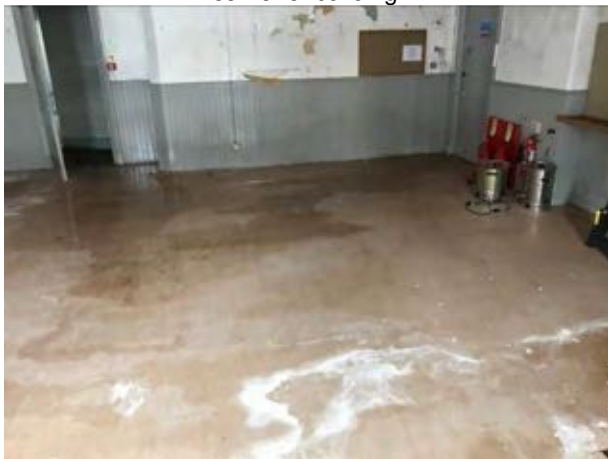
Photo 27. Severe water ingress/damage within room 0/012

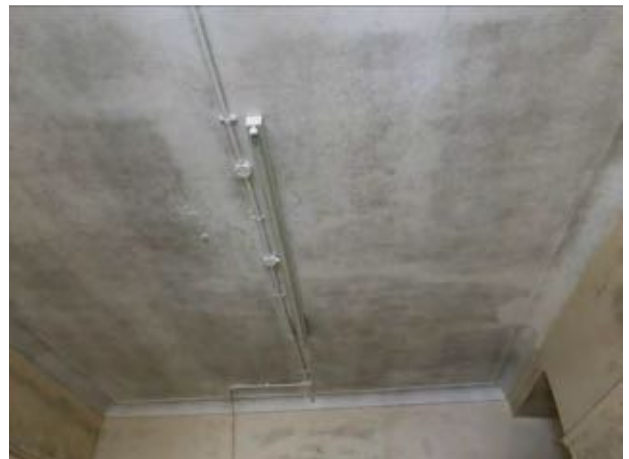
Photo 28. Mould growth to ceiling within room 0/008 Cloakroom

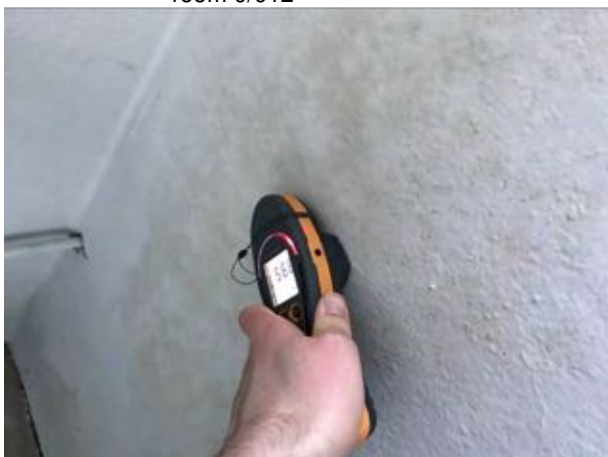
Photo 29. High moisture readings in Male Toilet

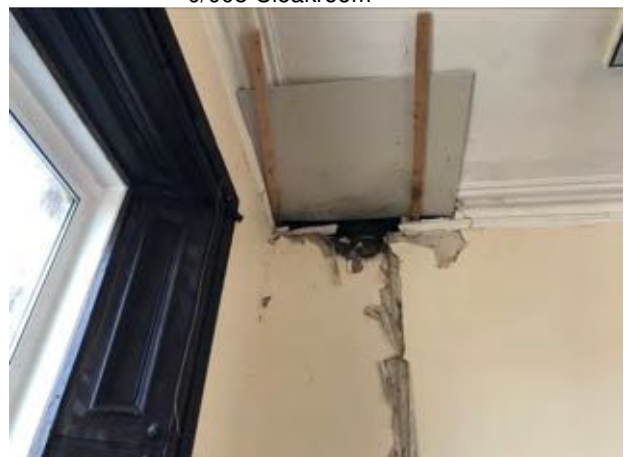
Photo 30. Water damage to ceiling within room 0/007 Office

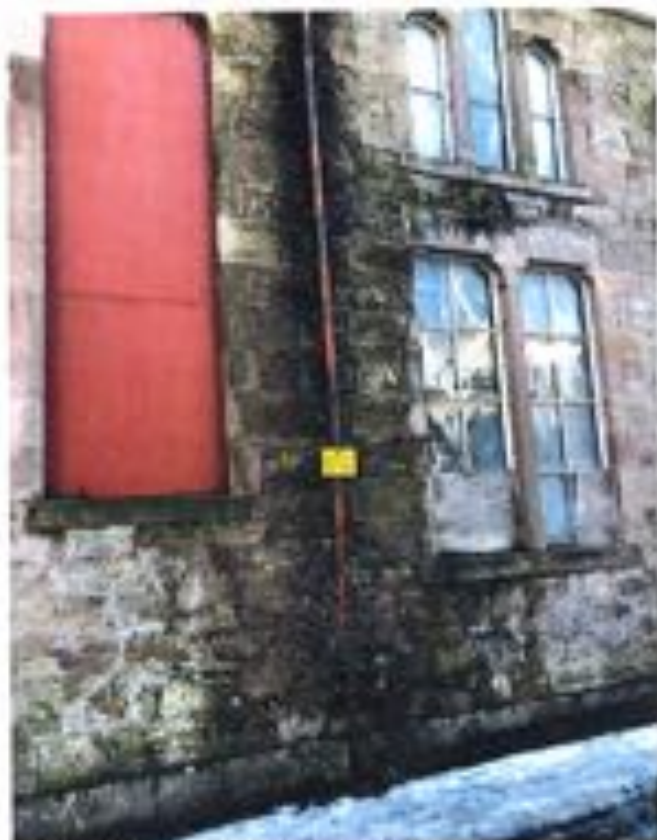
Signs of dampness along Howard Street

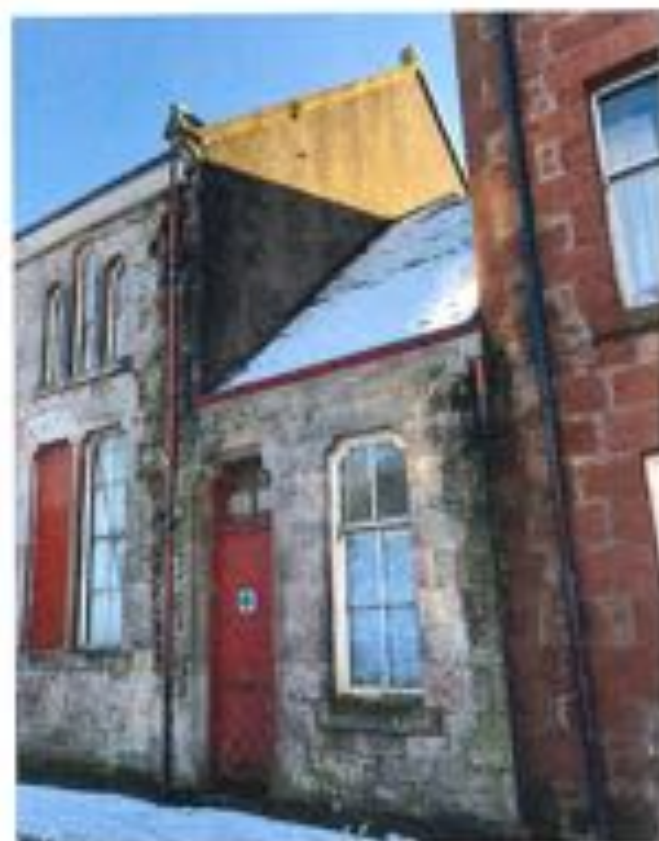
Southwest gable elevation - render cracking

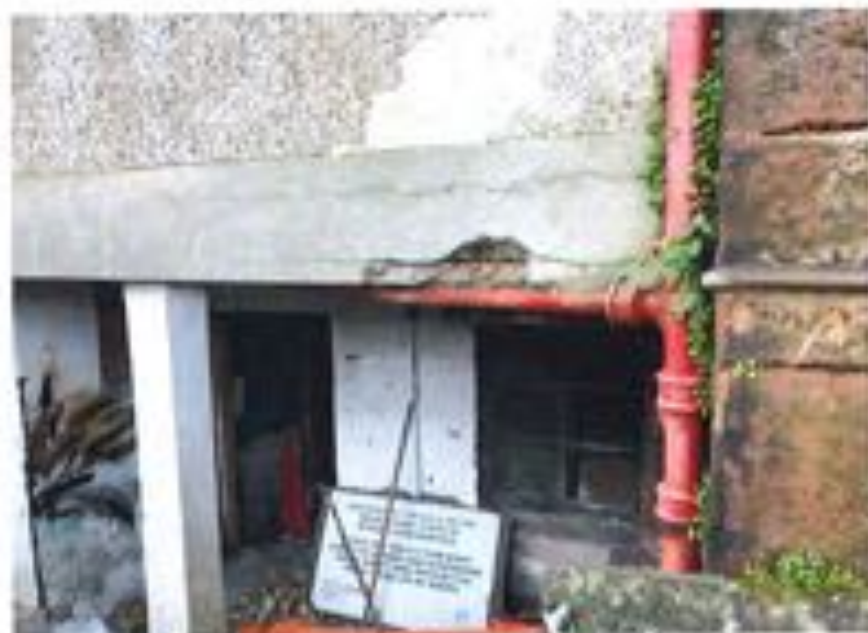
Southeast elevation - Damaged steelwork, concrete & masonry

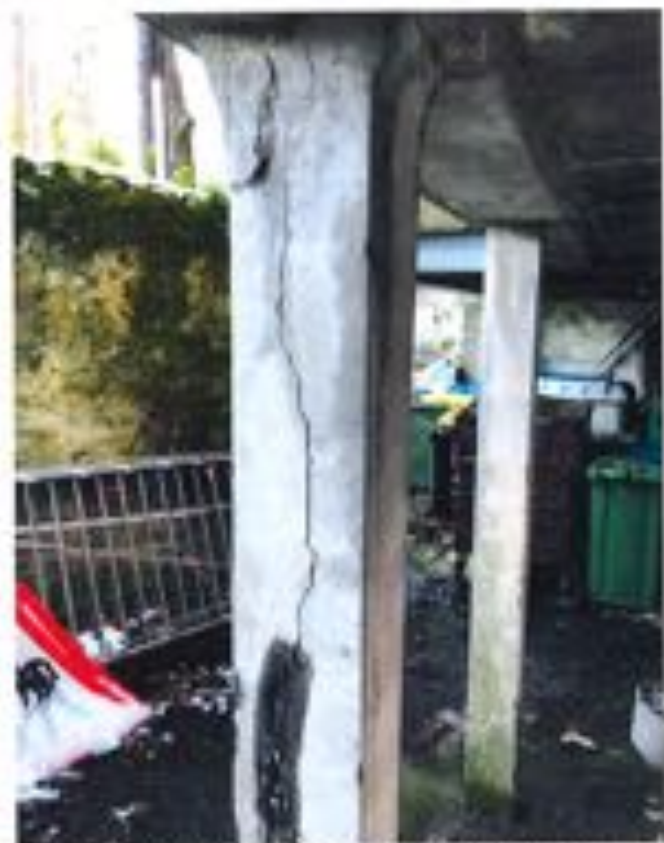
Southeast elevation - Damaged support columns

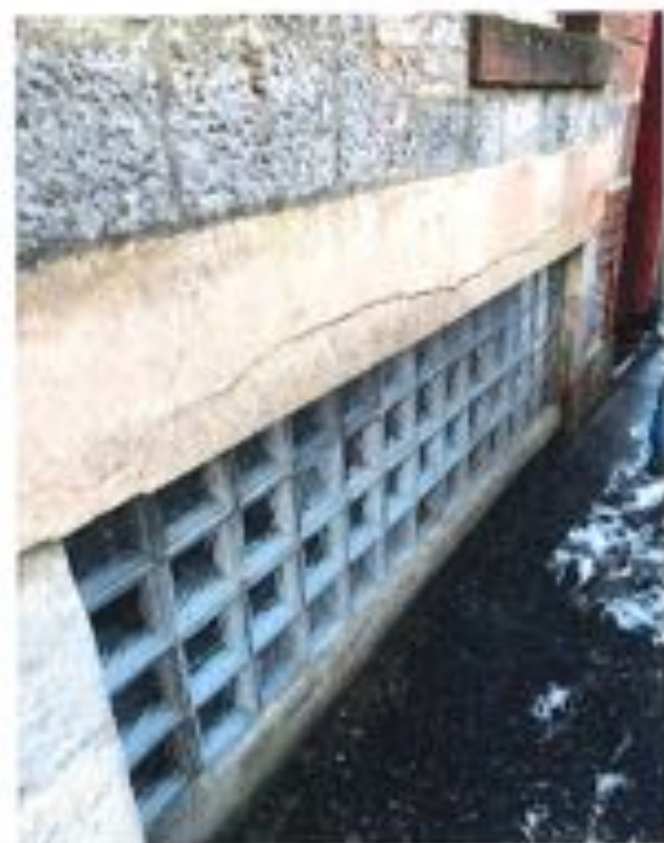
Clifton Street elevation - cracking across lintels

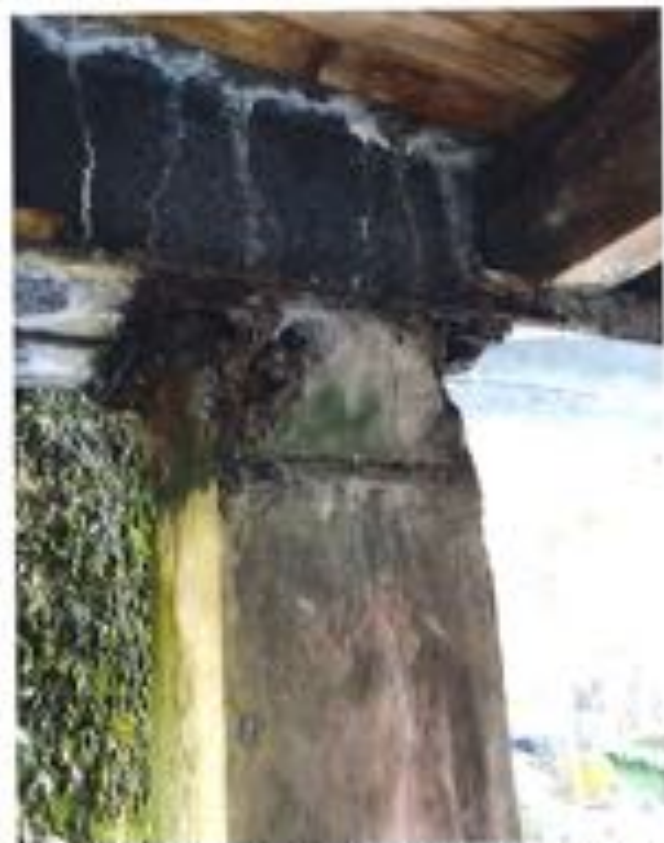
Southeast elevation/undercroft - Damaged steelwork

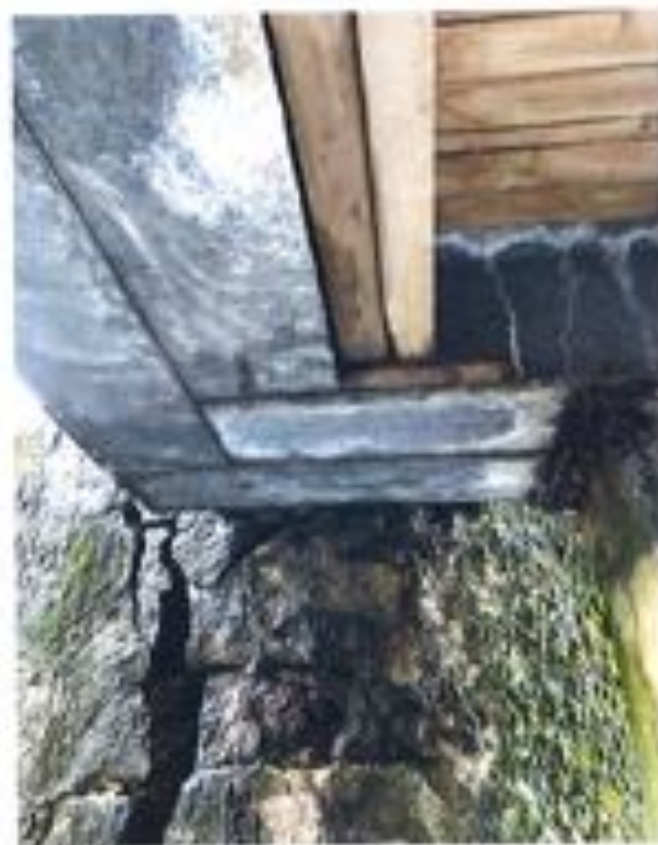
Southeast elevation/undercroft - Damaged masonry

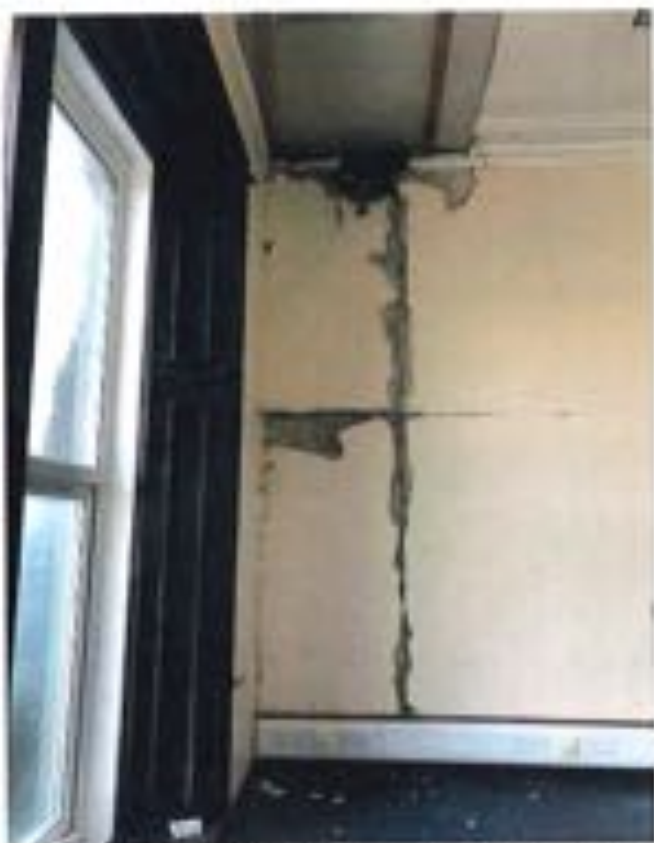
Small hall (along Clifton Street) - Water ingress/dampness

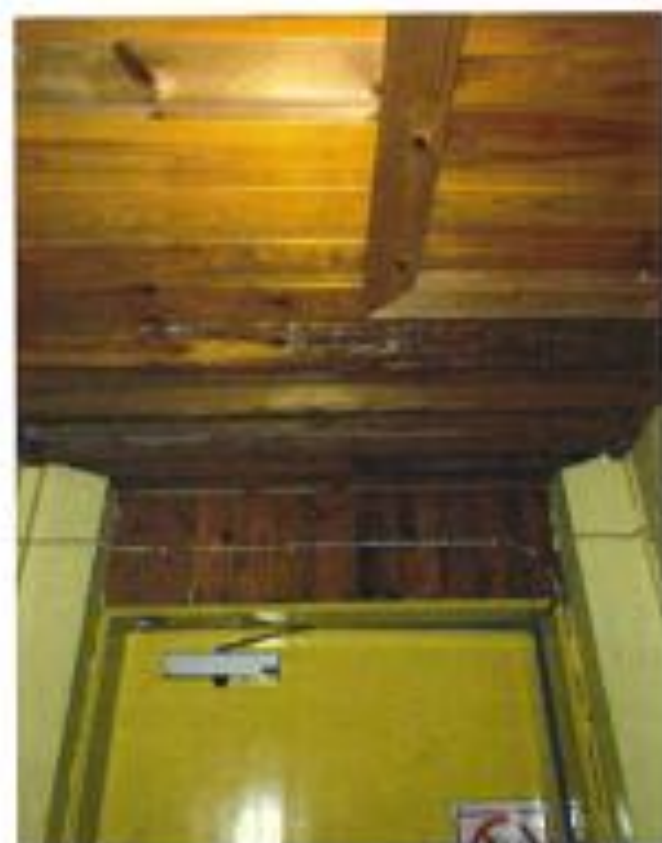
Ground floor hallway - Water ingress/dampness

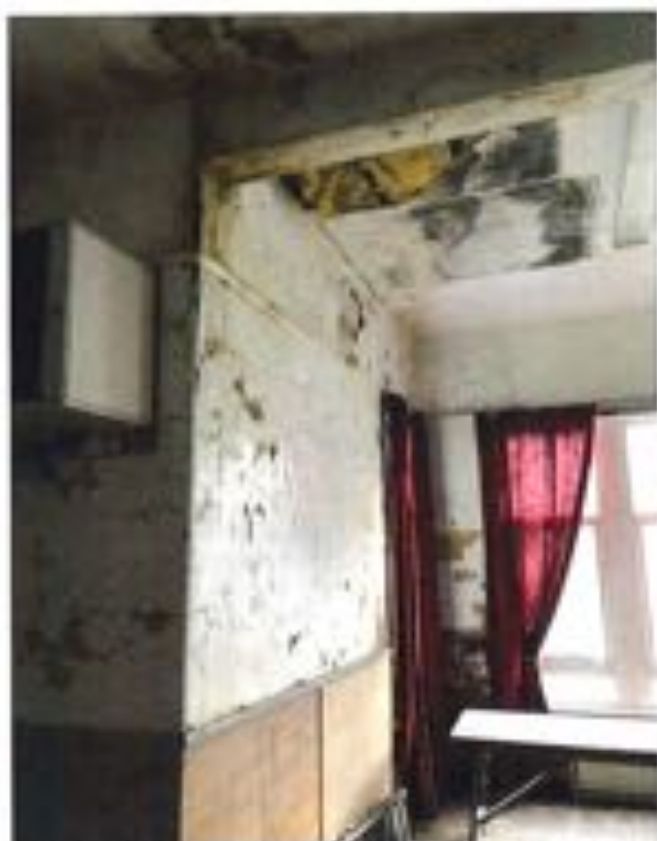
Small rear hall - Water ingress/dampness & damage

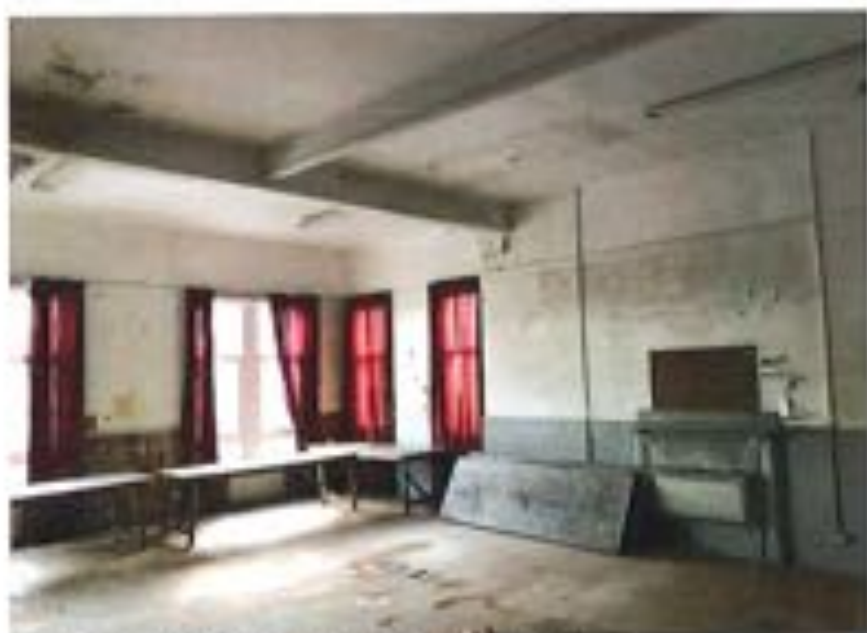
Small rear hall - Water ingress/dampness & damage

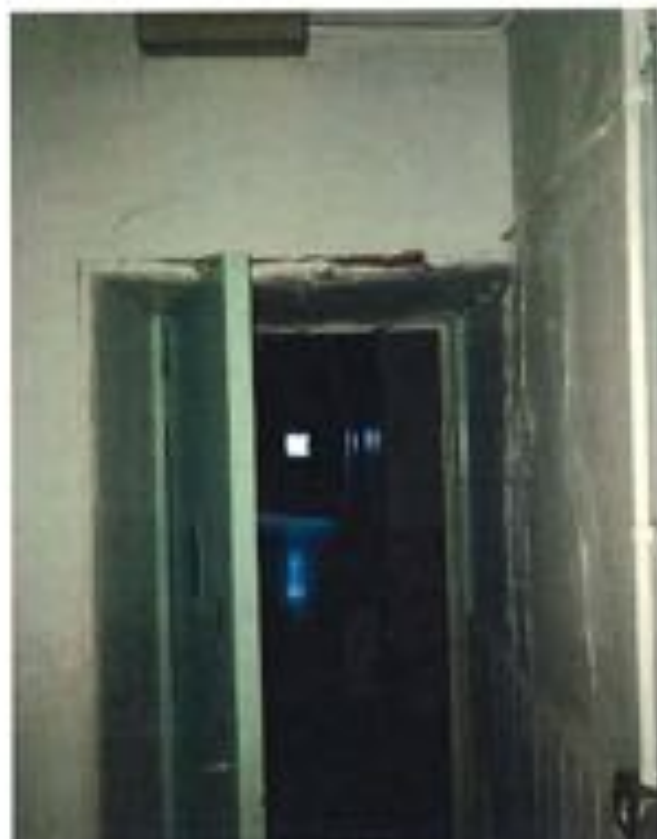
Main hall rear wall (Southwest gable) - damaged lintel(s)

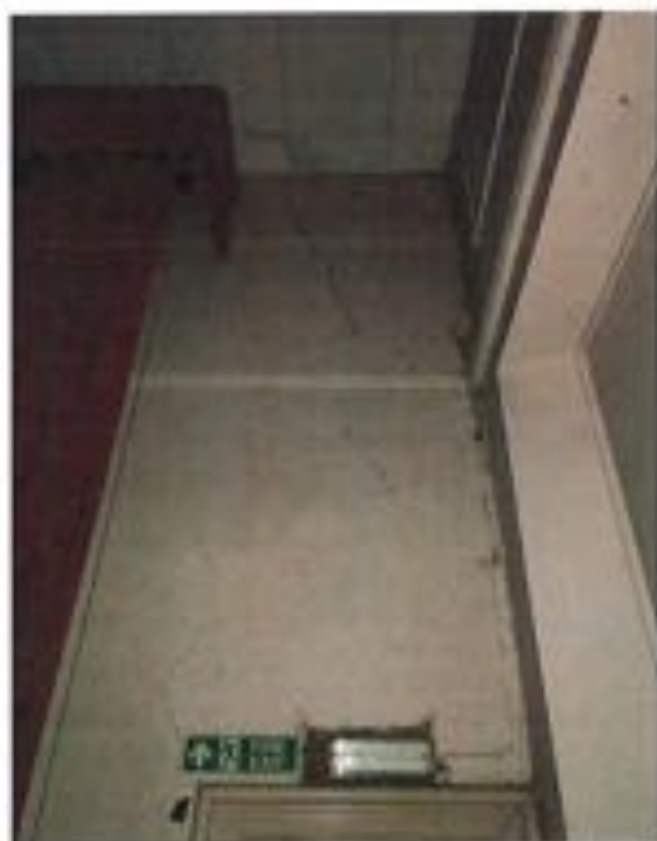
Main hall rear wall (Southwest gable) - cracking

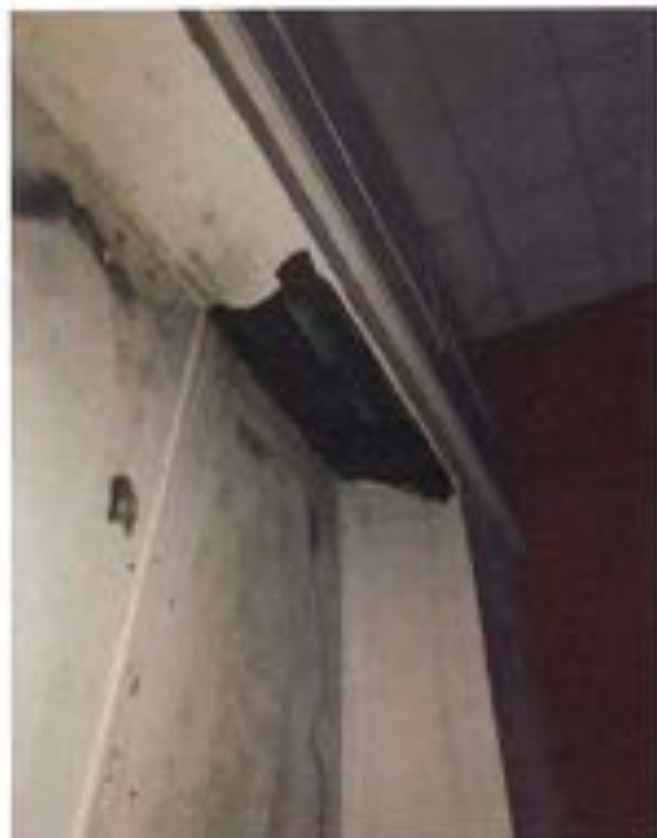
Main hall (Howard Street elevation) - Exposed lintels & water ingress

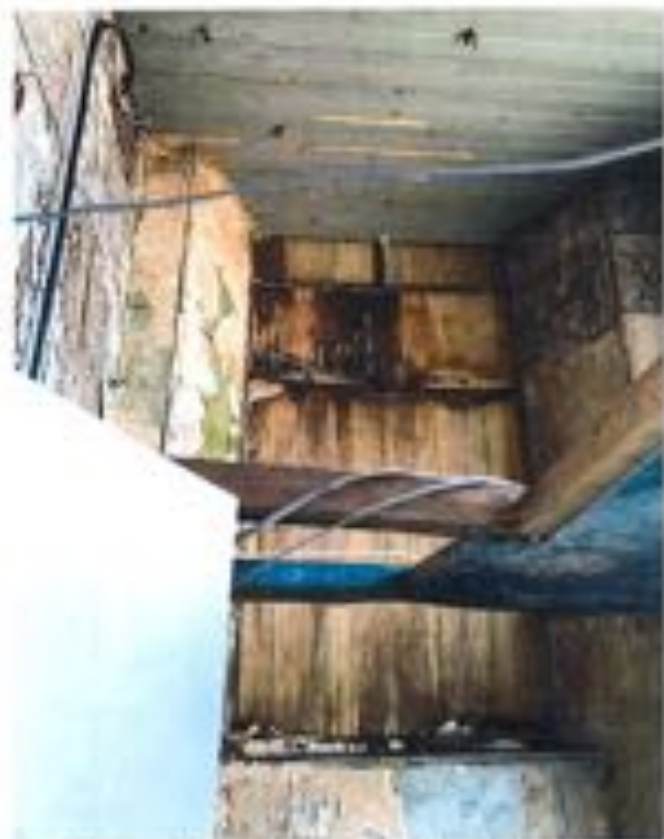
Main hall (Howard Street elevation) - Water ingress/dampness

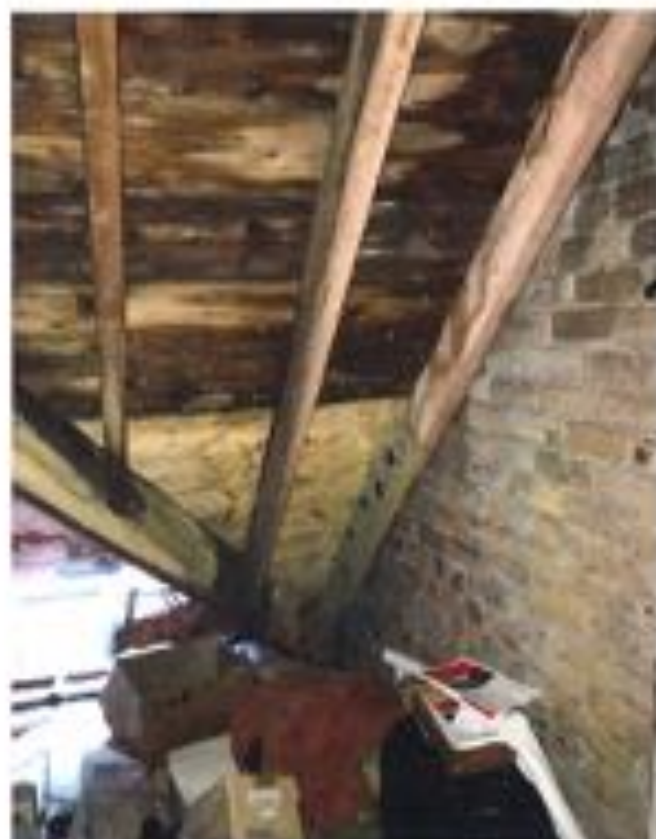
Attic roof void - Signs of dampness/water ingress & previous repairs

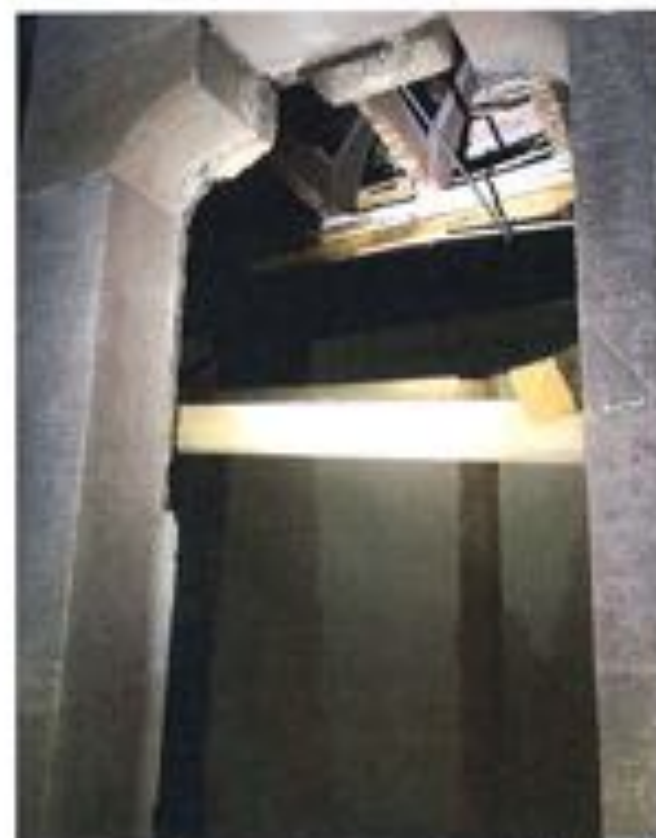
Attic roof void - Previous repairs & remedial works

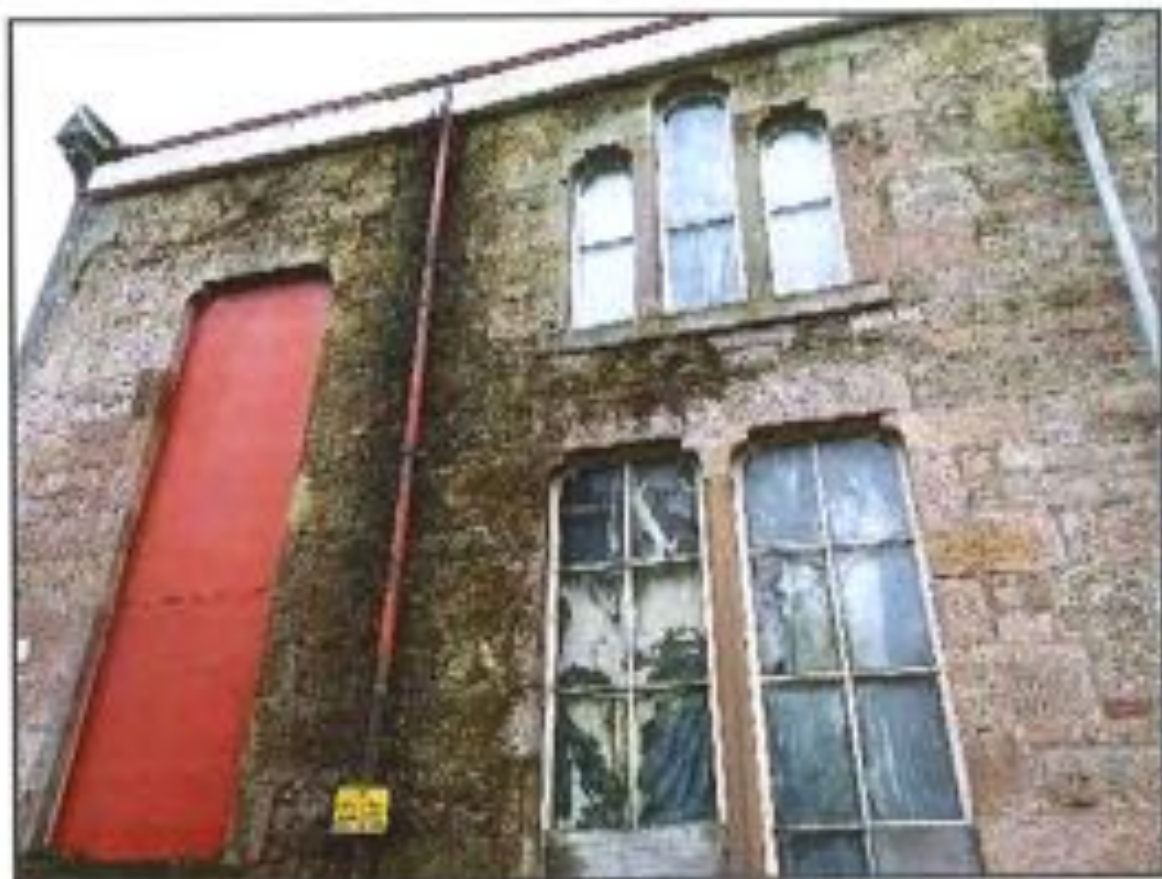
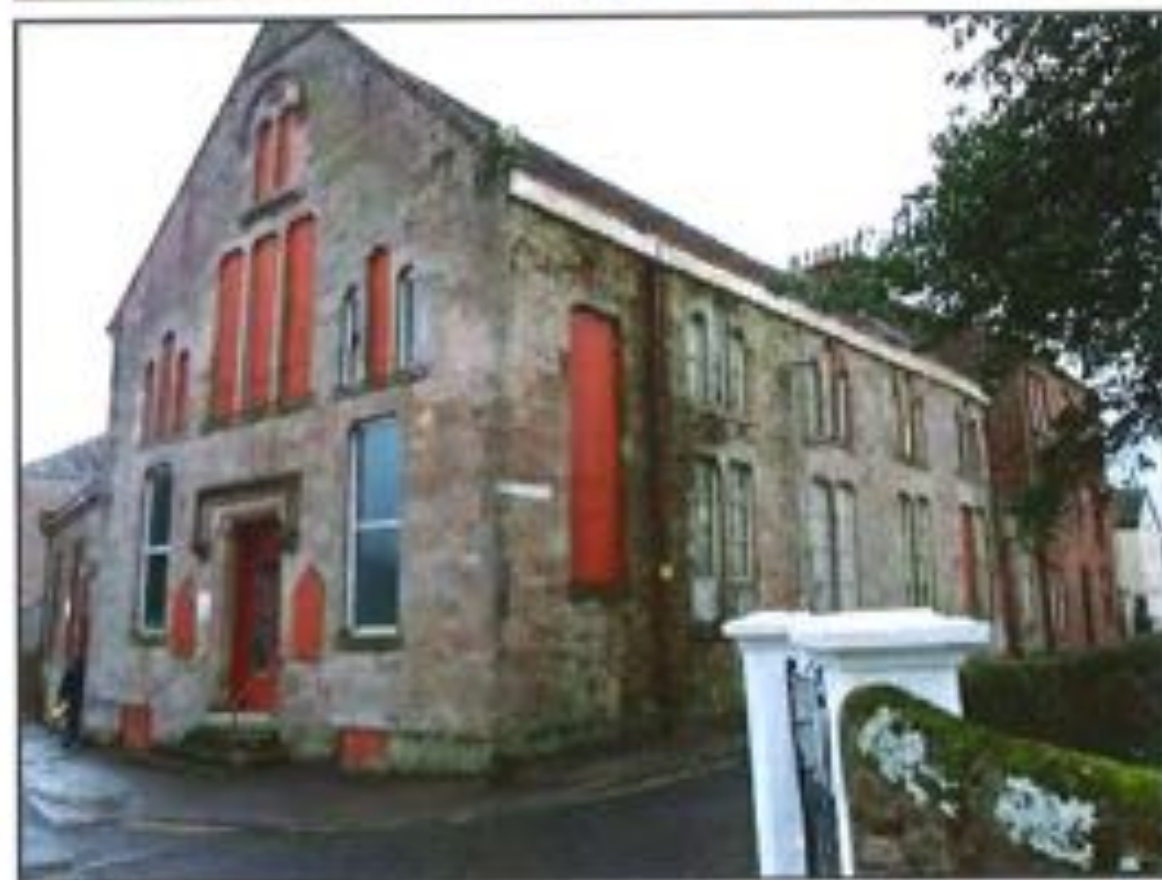
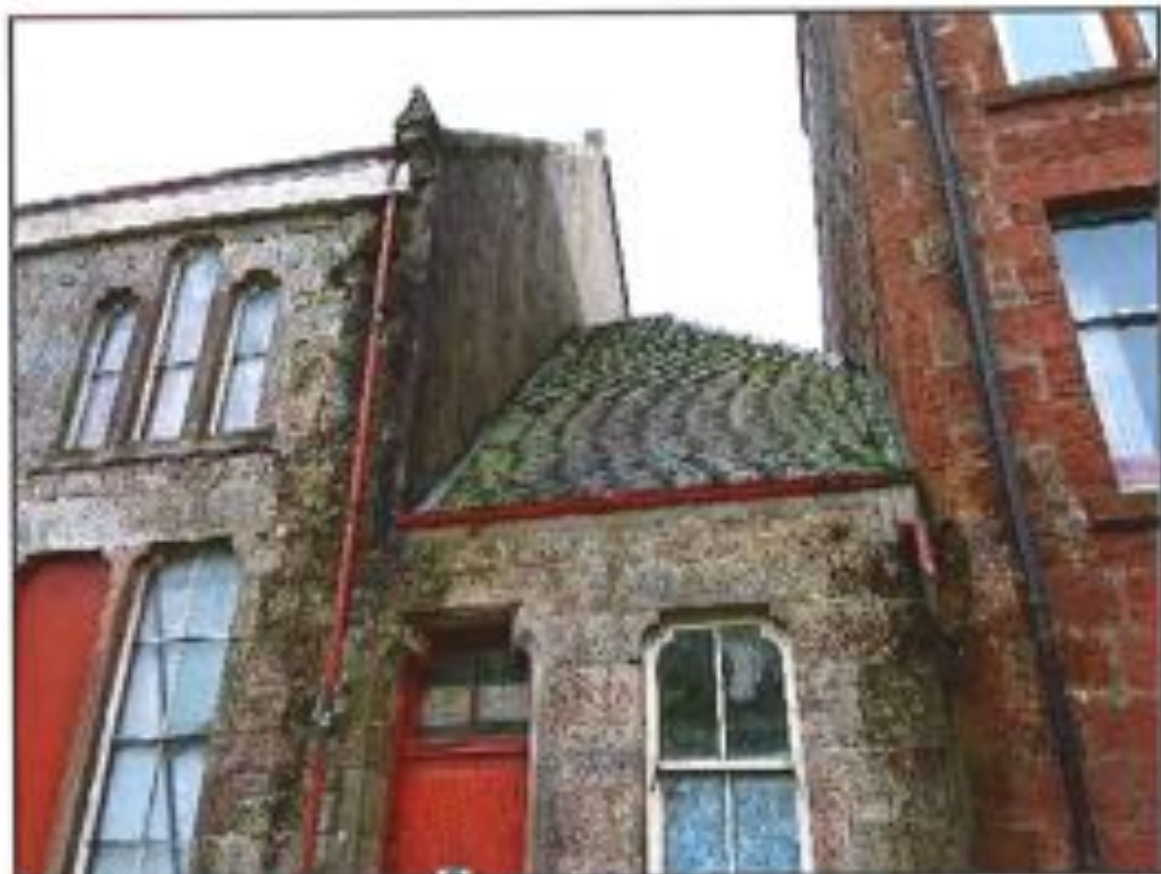
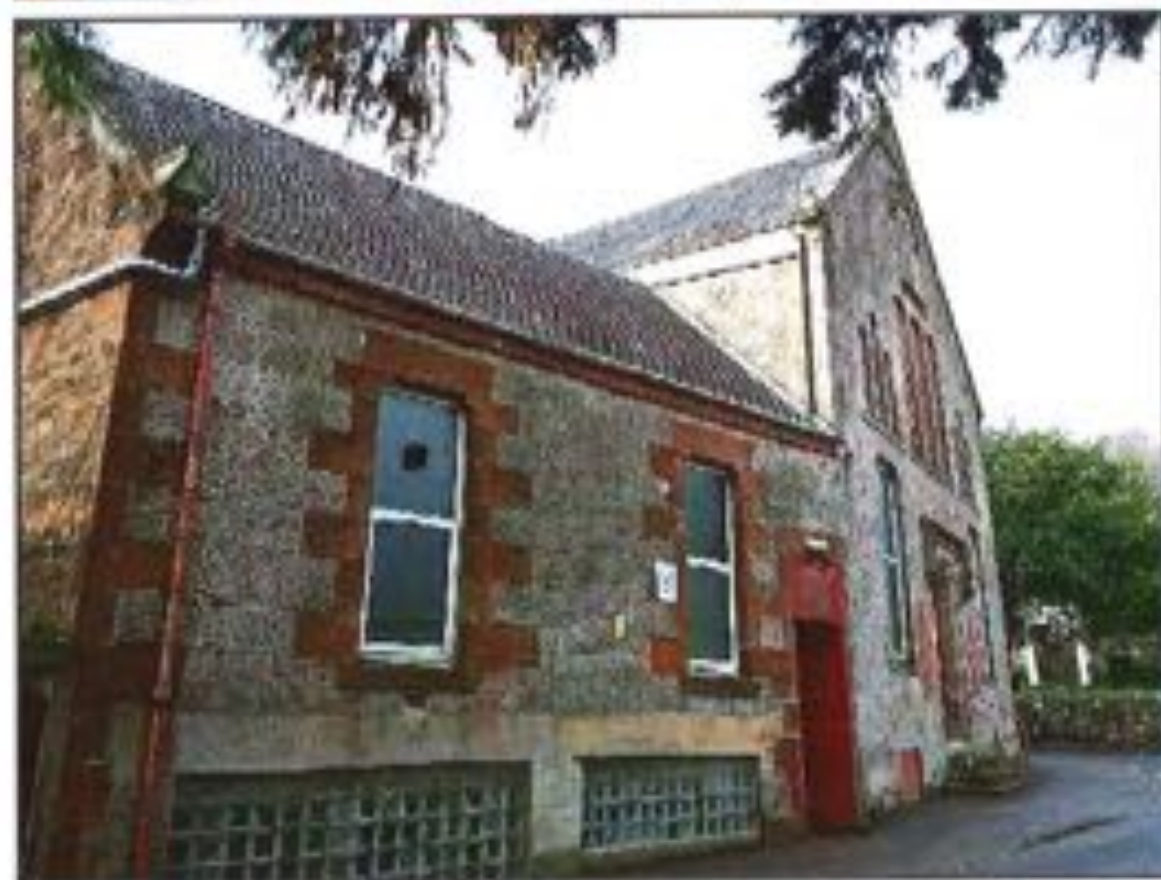
• Defective roof coverings

Client to instruct the services of a reputable roofing contractor to carry out a full survey of all roof coverings and water management systems.

Client to arrange for a reputable building contractor to carry out an external inspection of all masonry including making comment on the existing timber windows.
