**MILLPORT TOWN HALL  
REPAIRS AND CONVERSION TO  
COMMUNITY FACILITY**

**FEASIBILITY COSTS  
FOR**

**FRIENDS OF MILLPORT TOWN HALL**

**MAY 2019**

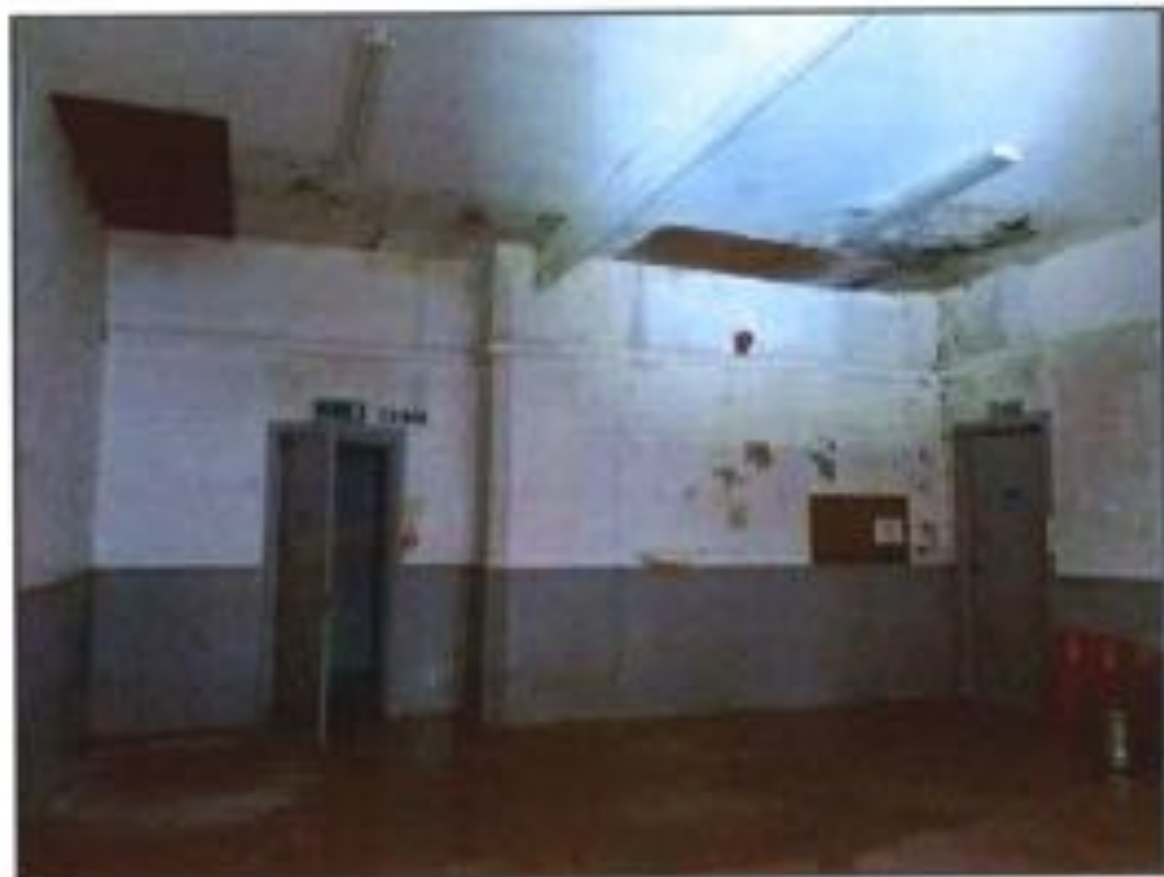
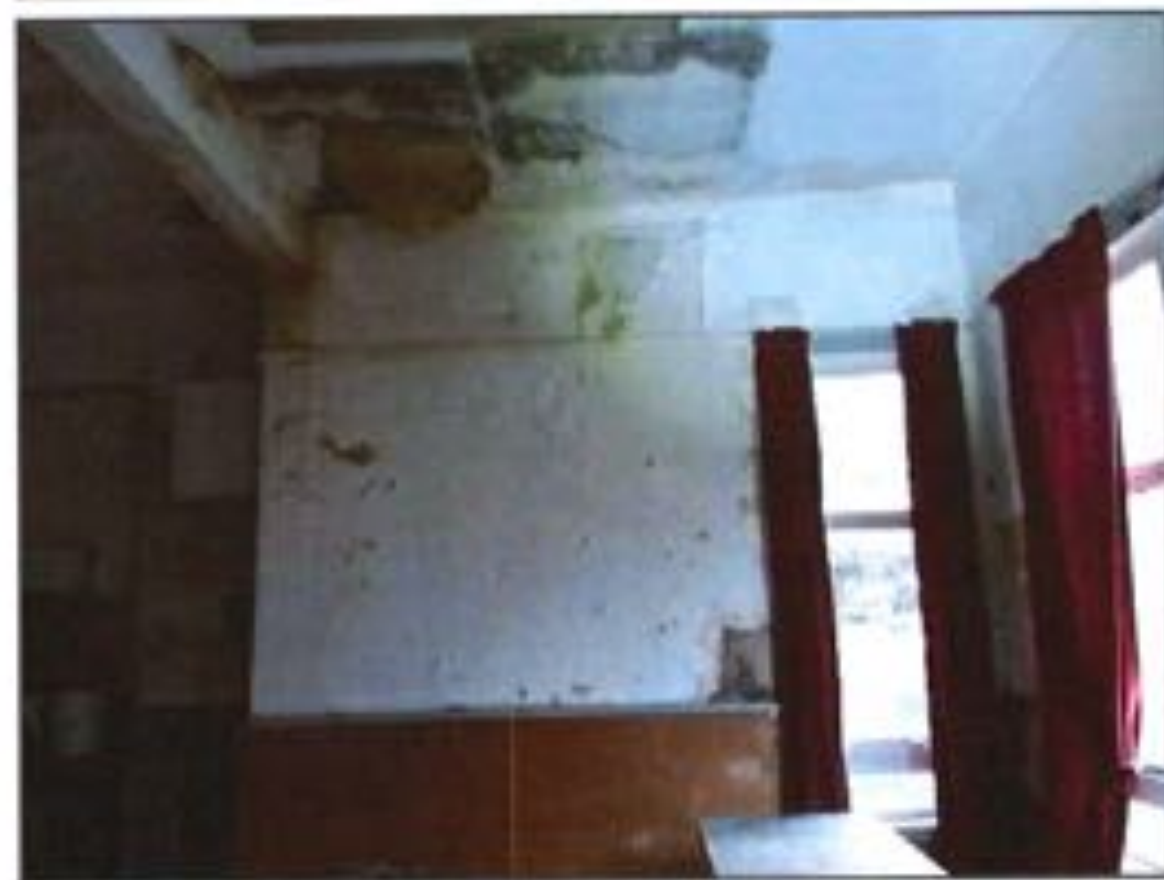
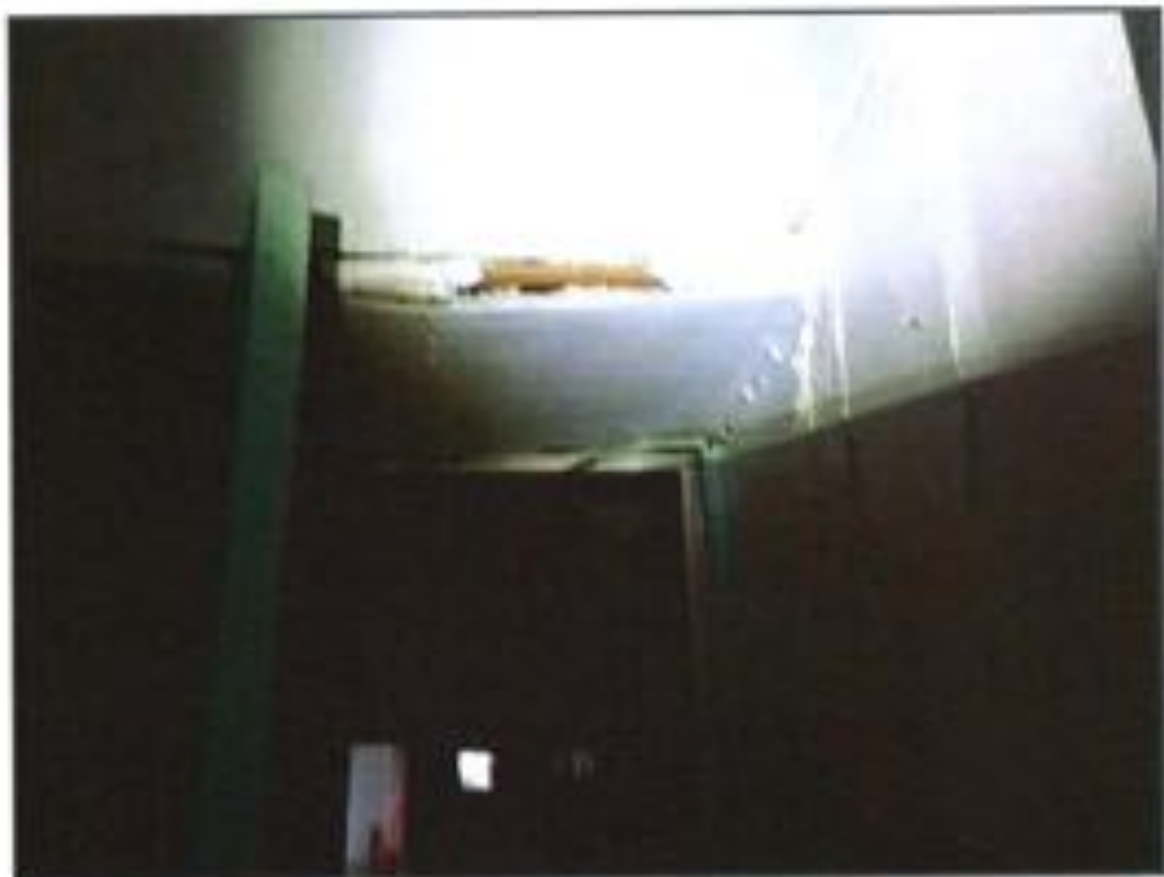
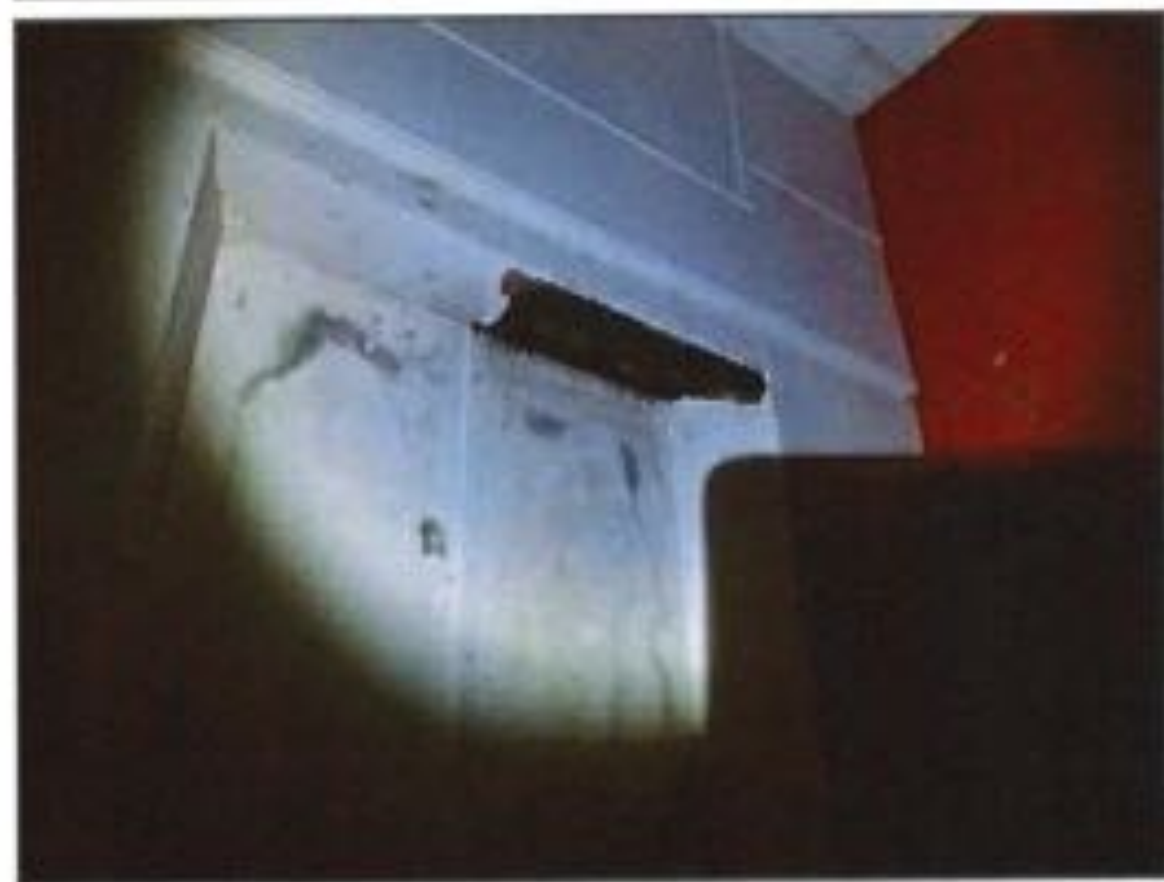
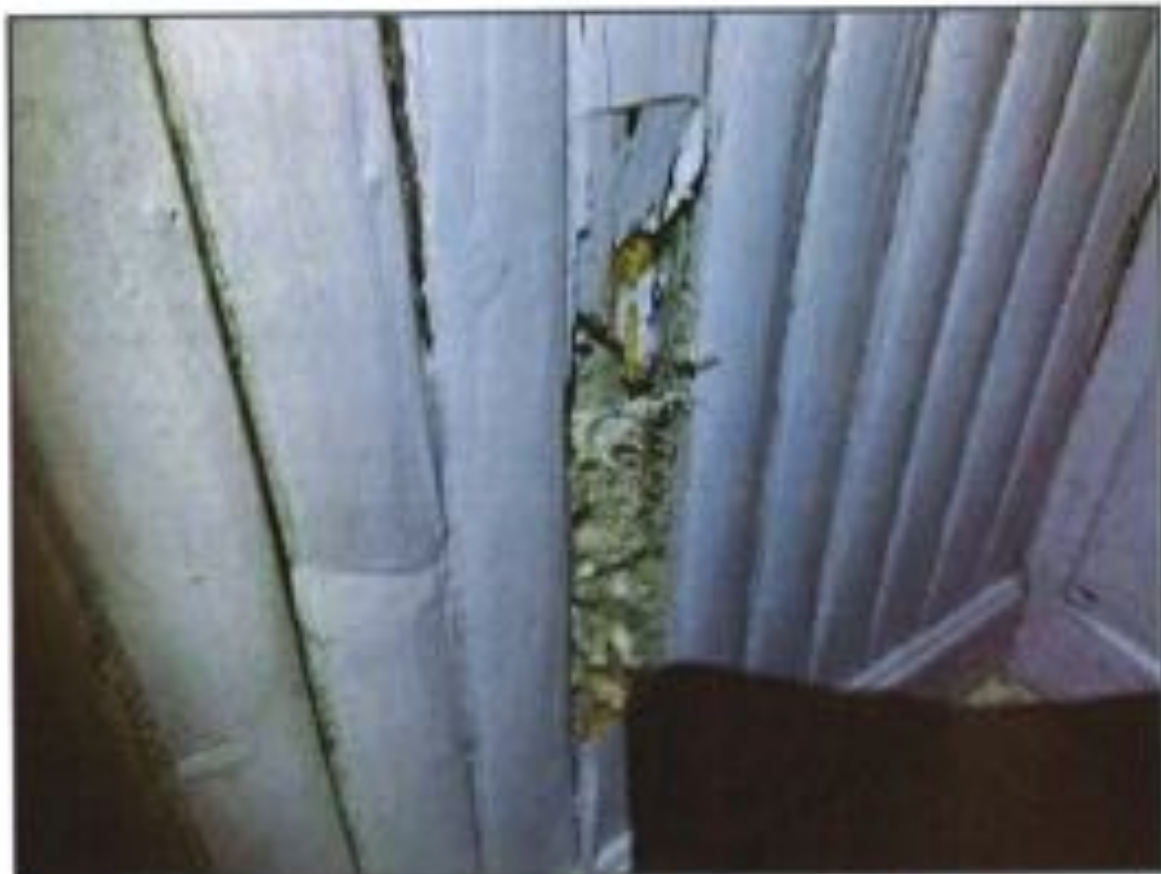
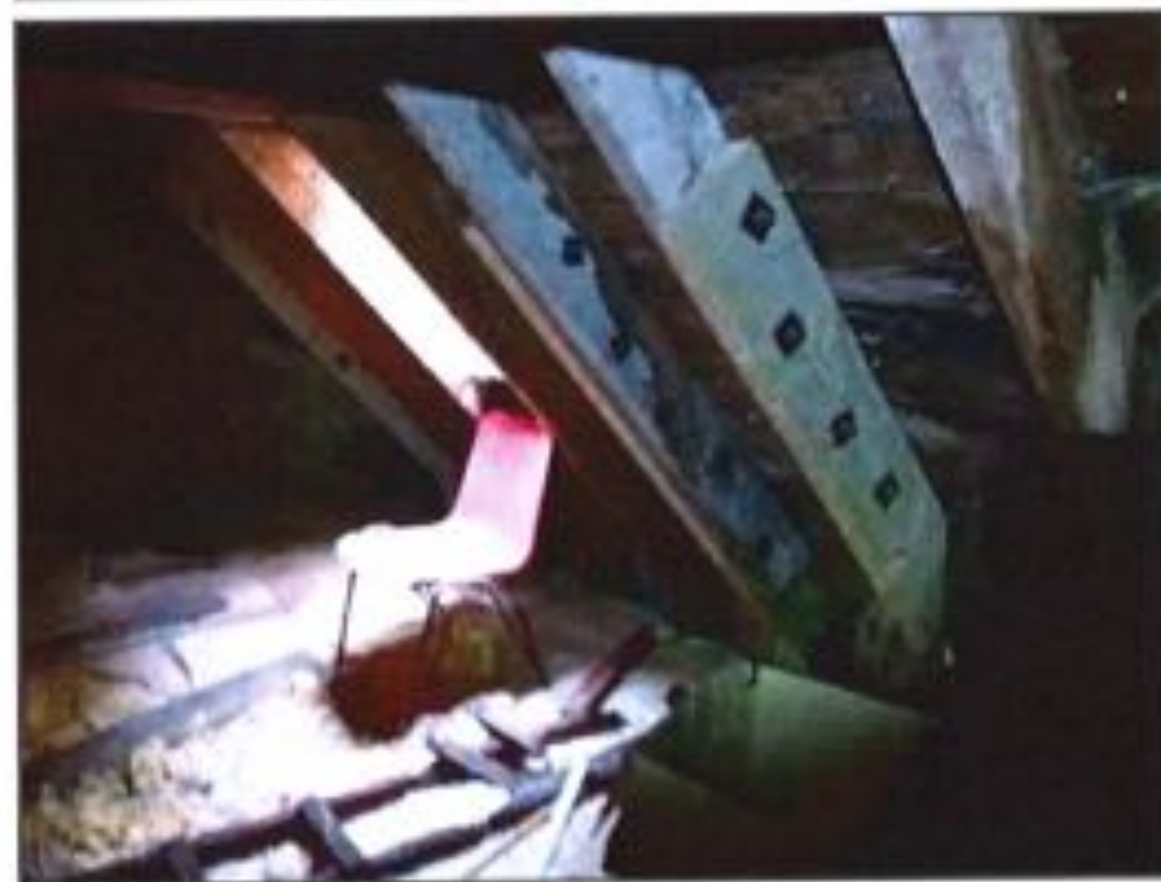
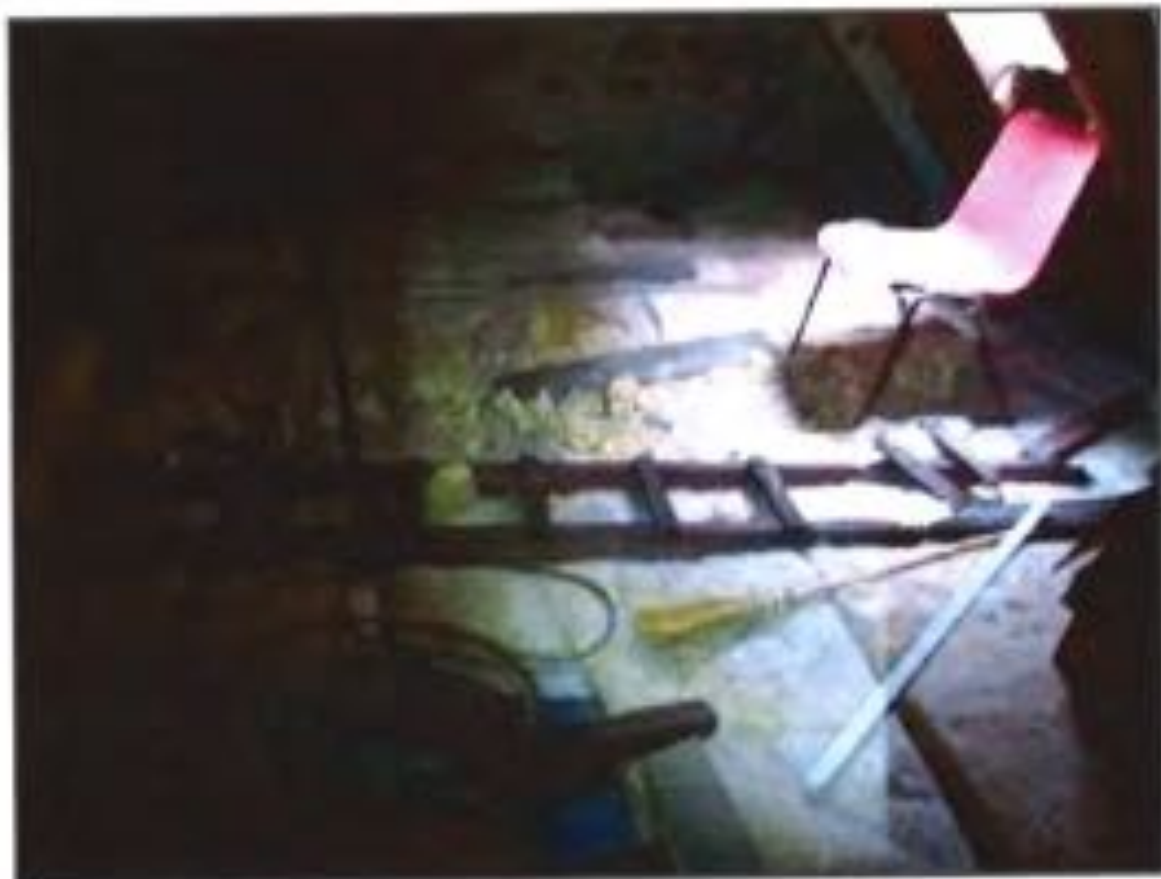
During the course of our visual inspection within the basement block it was noted that the construction of the ceiling/ground floor joists would appear to consist of an internal perimeter steel ring beam which is supporting the ground floor joists. The ground floor joists appear not to be built into the masonry where visually inspected.

Our inspection also revealed areas of water staining to the underside of the ground floor joists/T&G flooring where viewed from within the basement. Our inspection at ground floor level confirmed the presence of water lying on the top surfaces of floor coverings suggesting ingress from roof coverings.
