**MILLPORT TOWN HALL  
REPAIRS AND CONVERSION TO  
COMMUNITY FACILITY**

**FEASIBILITY COSTS  
FOR**

**FRIENDS OF MILLPORT TOWN HALL**

**MAY 2019**

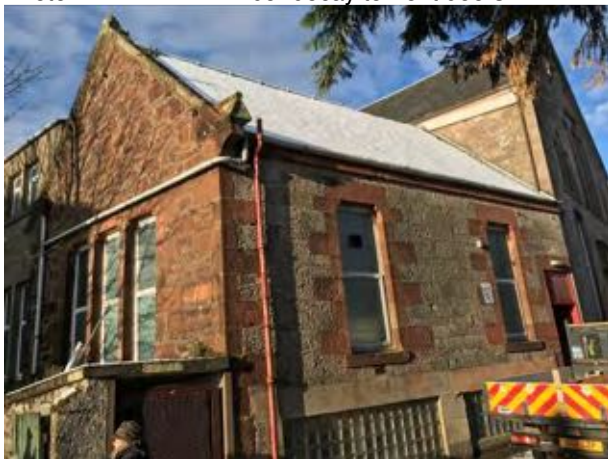
Photo 9. South-east corner elevations

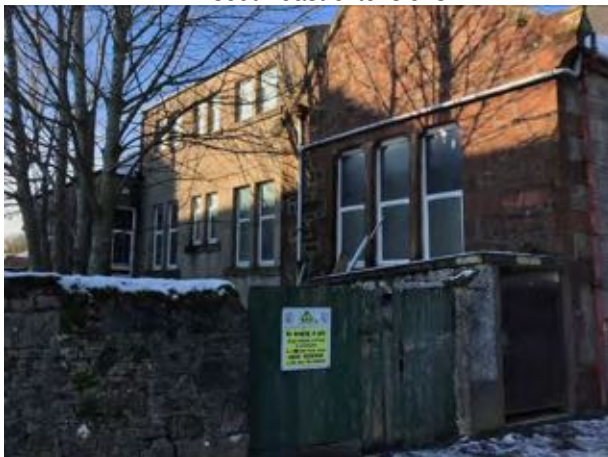
Photo 15. General of south-east elevations
