**MILLPORT TOWN HALL  
REPAIRS AND CONVERSION TO  
COMMUNITY FACILITY**

**FEASIBILITY COSTS  
FOR**

**FRIENDS OF MILLPORT TOWN HALL**

**MAY 2019**

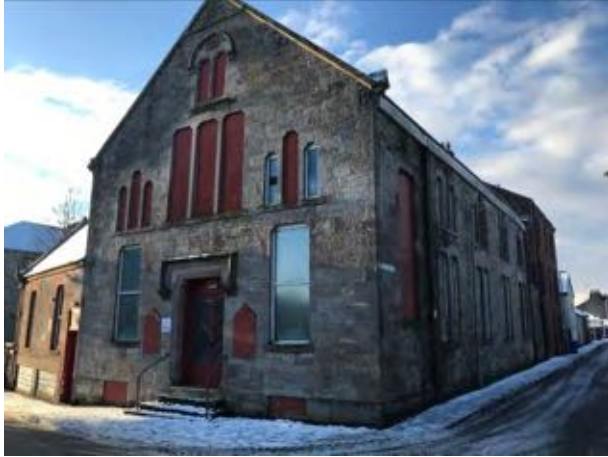
Photo 1. General front elevation

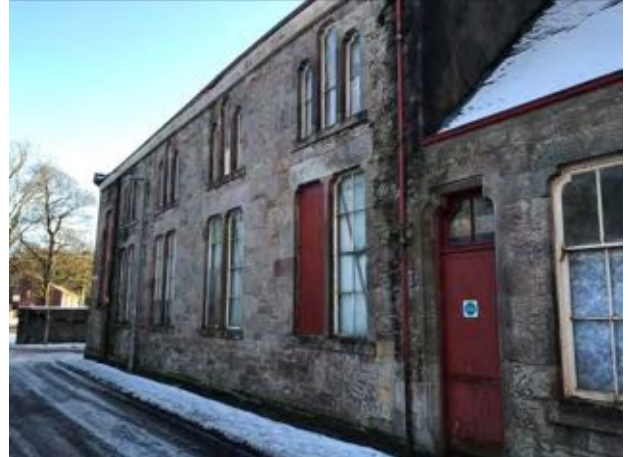
Photo 2. General Howard Street elevation

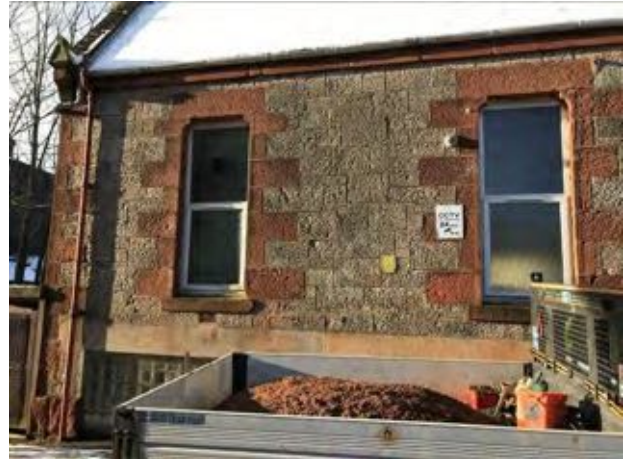
Photo 8. General front facing elevations

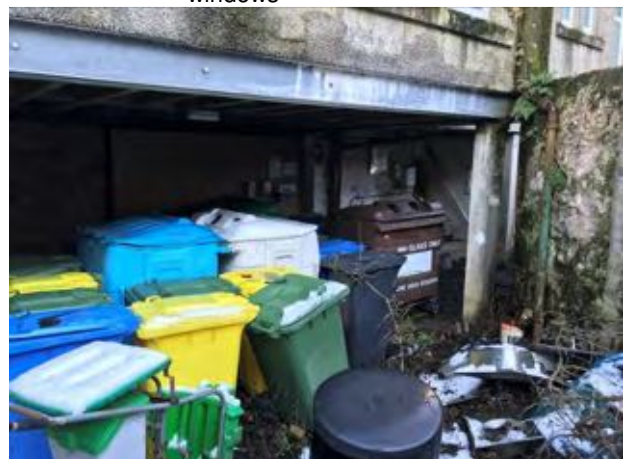
Photo 12. General view of grounds
